**Control Wheel Shaft Inspection Guide**  
**Piper SB-1197A/B**  
**AD 2010-15-10**

**Ray Liles @ KMLB**  
**N316X PA-28R-200**  
**October 17, 2010**

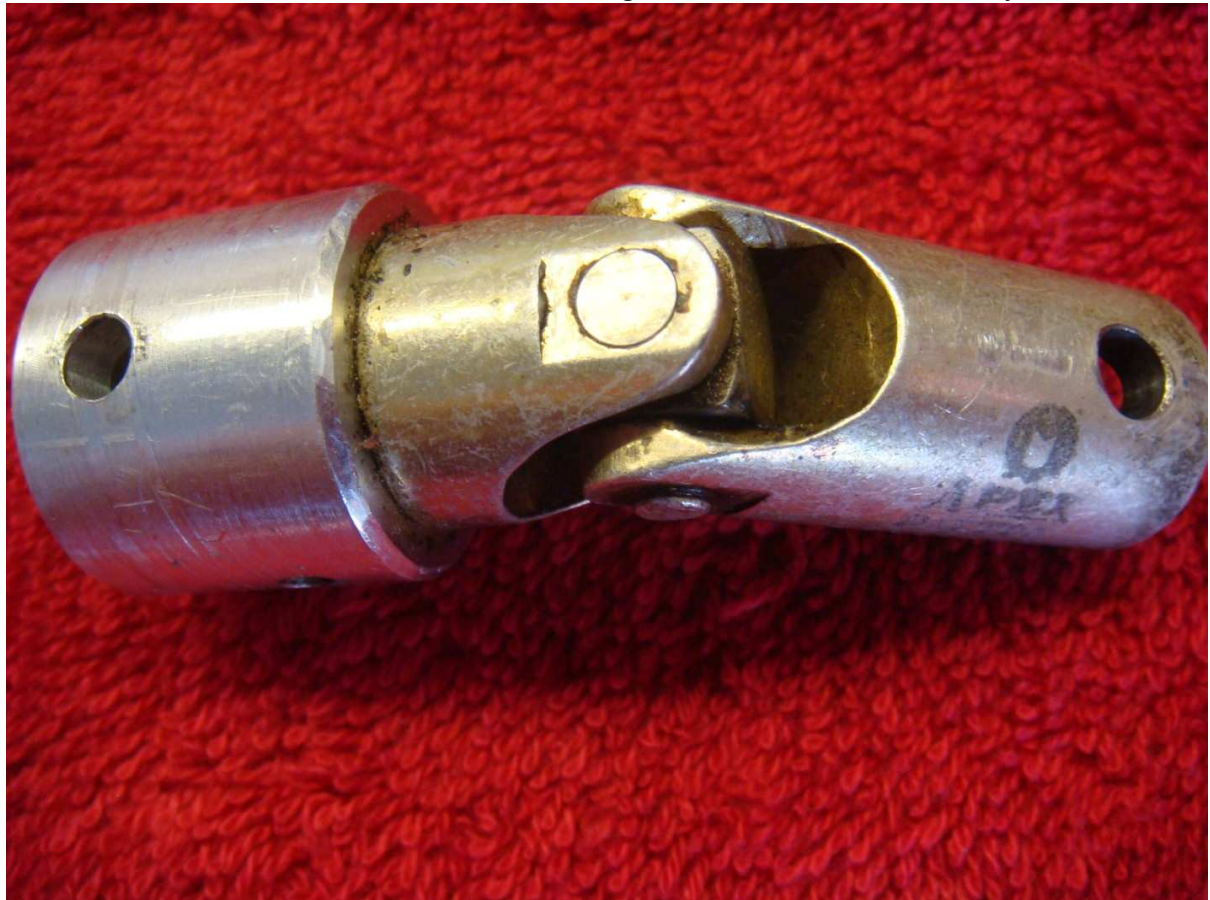
This is what the control shaft universal looks like (worn unit from my previous aircraft). What's important to note is that there is NO WAY to insert a tool or measuring rod into the back side of the joint. It is solid!

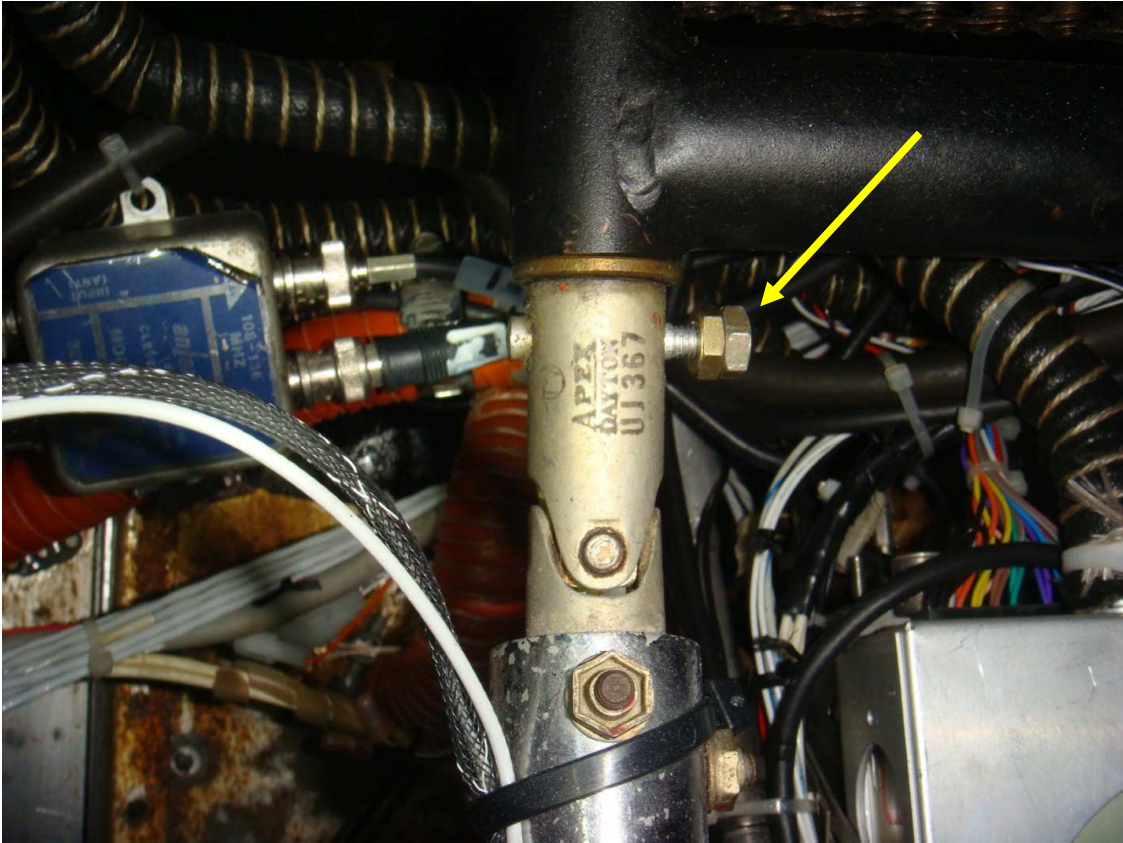
I installed 2 nuts, flush with the tapered pin to provide a pressing surface for the chain breaker and to spread the load on the threads, to avoid bending the pin

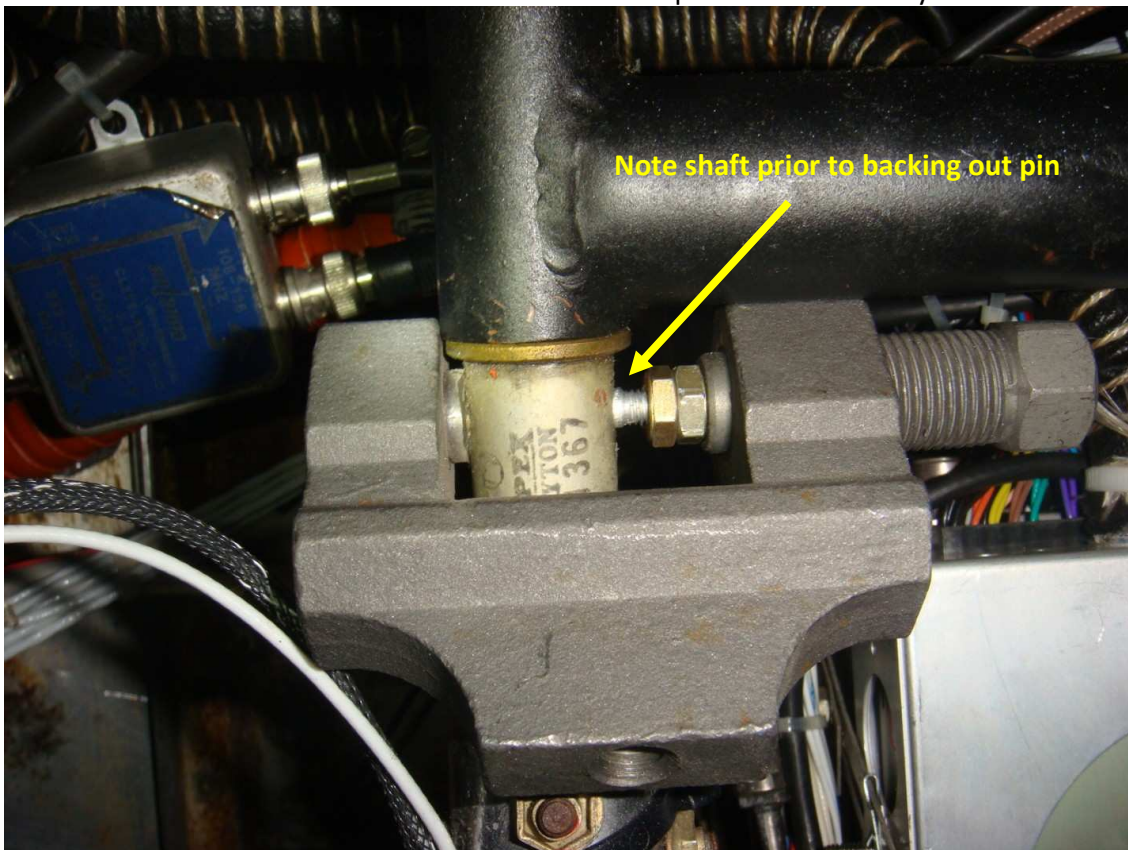
Install the chain breaker – note the clearance from the control sprocket. This is why the collet is needed.

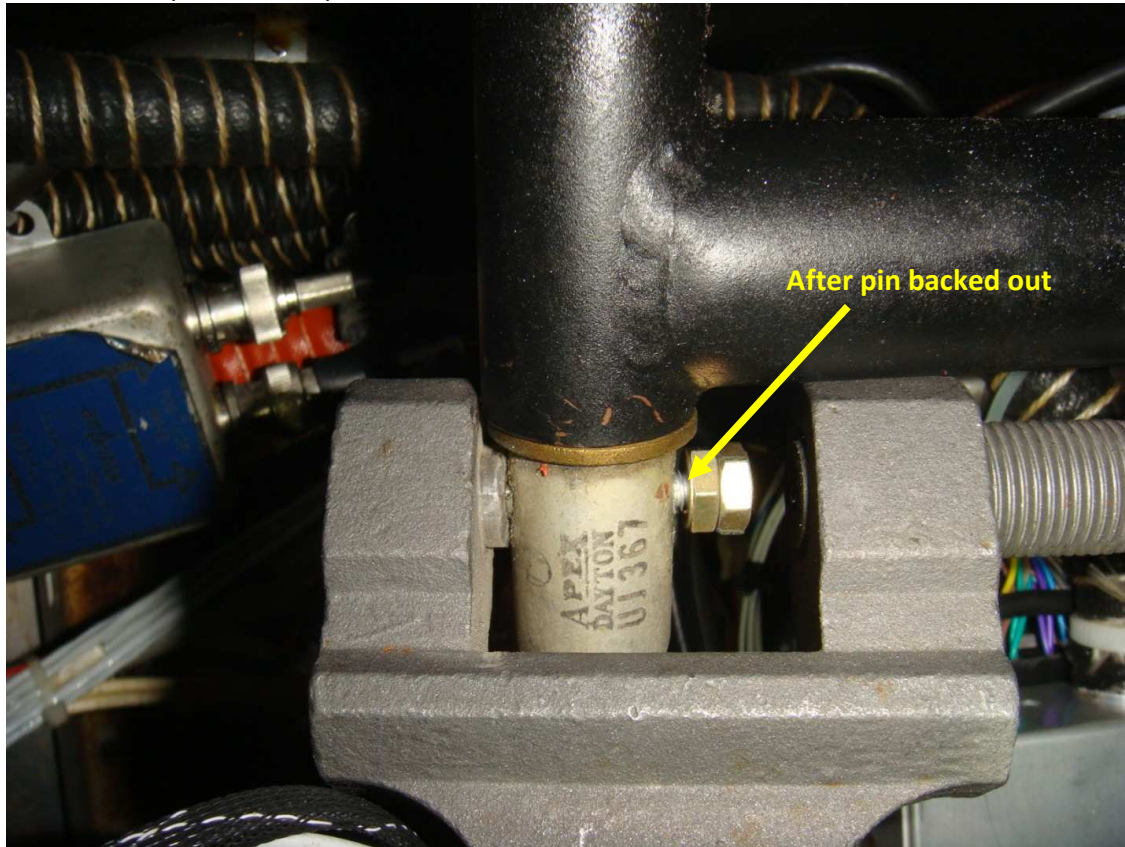
Using a 9/16" wrench or socket, slowly compress the pin, until it releases. In my experience, it required only moderate force. In this picture, the pin has been backed out – note the thread.

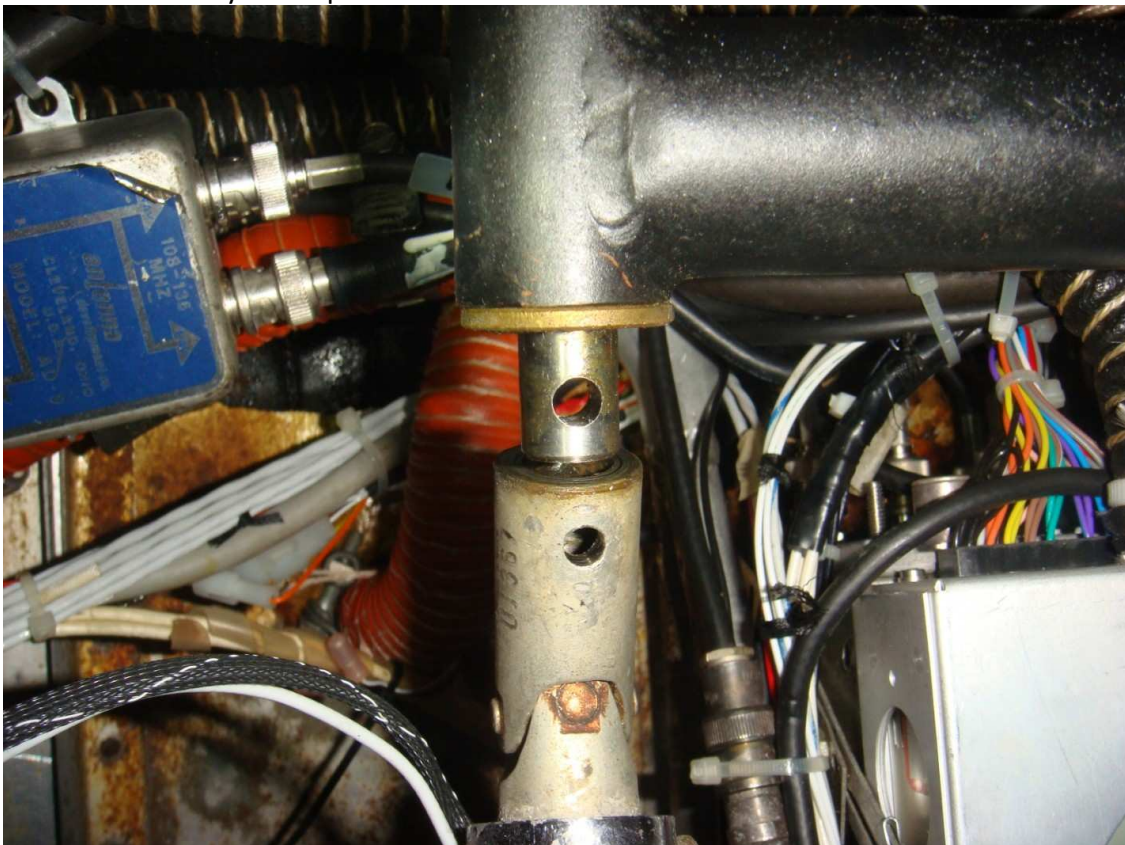
Tapered pin removed – ready for inspection

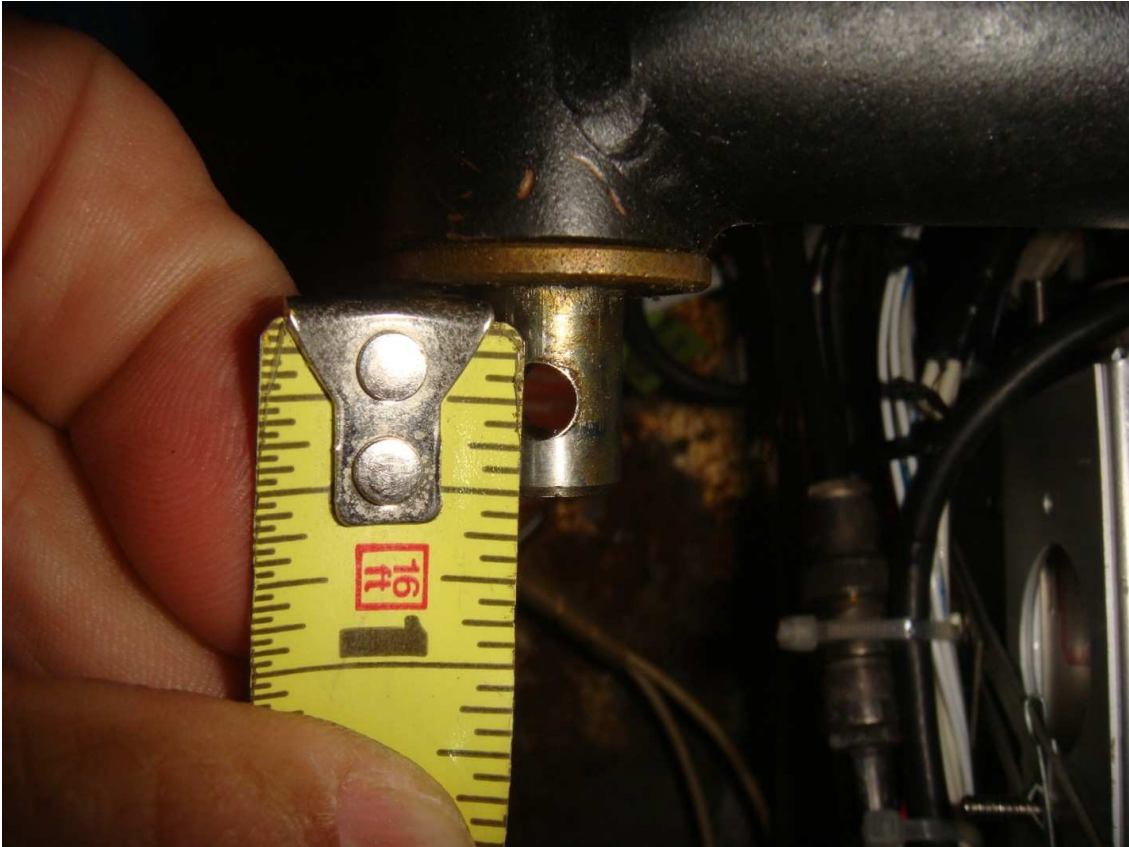
Center of tapered pin hole to end of shaft must be a minimum of 0.19 inches – mine both measured 0.25 inches
