**Control Wheel Shaft Inspection Guide**  
**Piper SB-1197A/B**  
**AD 2010-15-10**

**Ray Liles @ KMLB**  
**N316X PA-28R-200**  
**October 17, 2010**

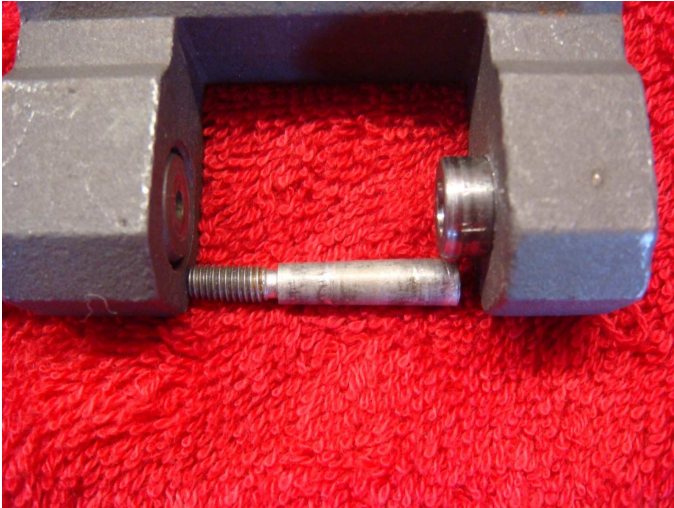
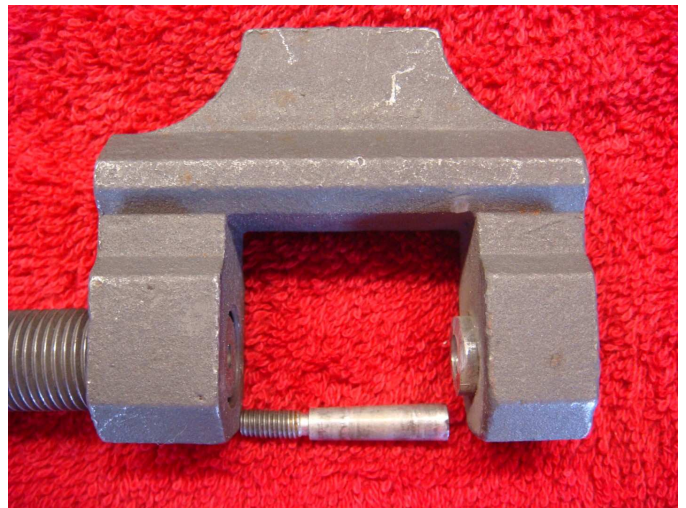
Following Garrett's recommendation, I drilled a  $\frac{1}{4}$ " hole in the collet and cut off  $\frac{1}{16}$ " from the collet surface. Trimming the collet allows an easier fit, but you can back out the bolt and wiggle the unit over the tapered pin.

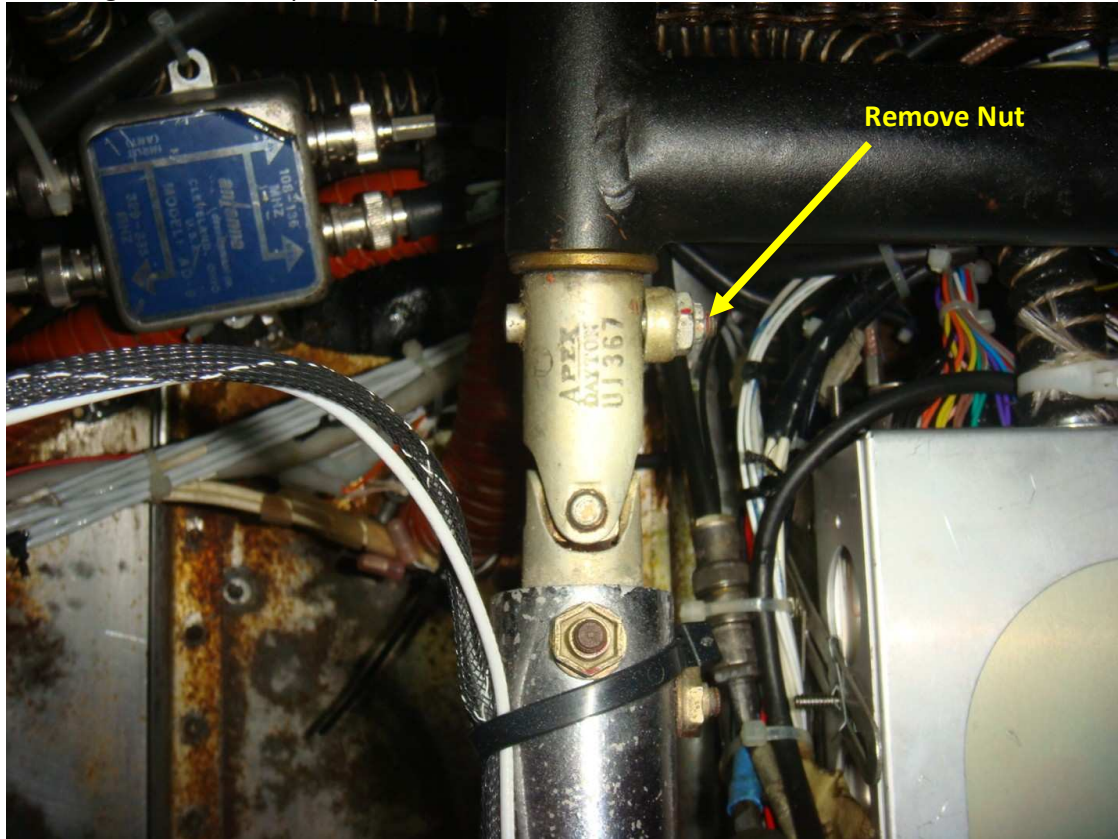
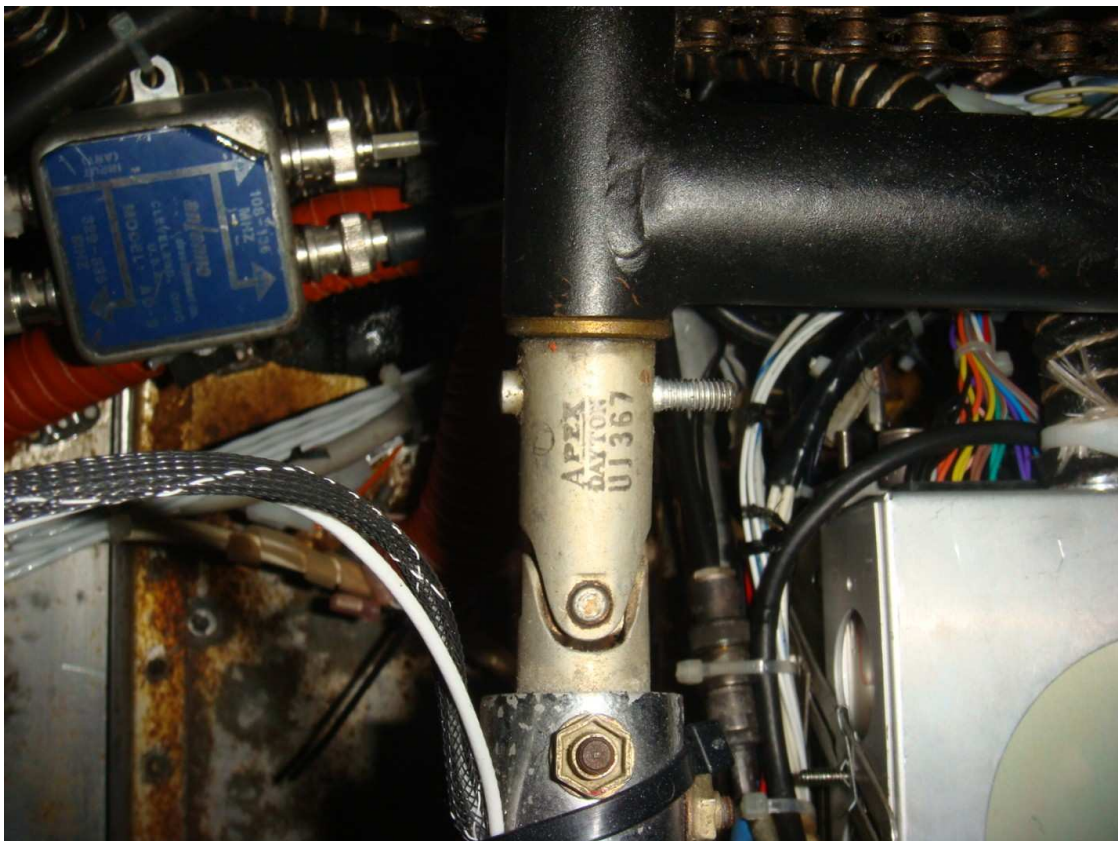
Remove the existing nut on the tapered pin
