Control Wheel Shaft Inspection Guide
Piper SB-1197C
AD 2010-15-10

Ray Liles @ KMLB
N316X PA-28R-200
October 17, 2010

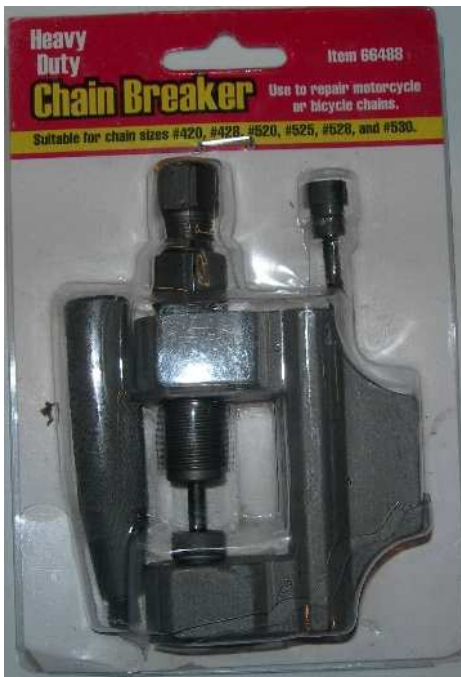
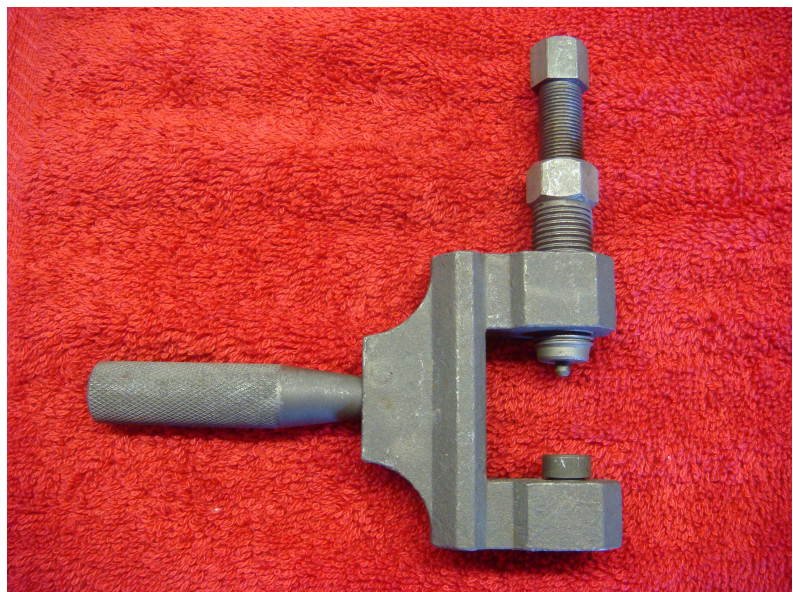
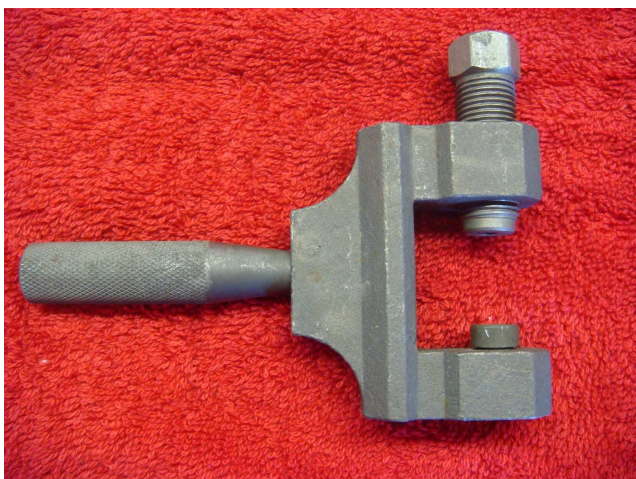
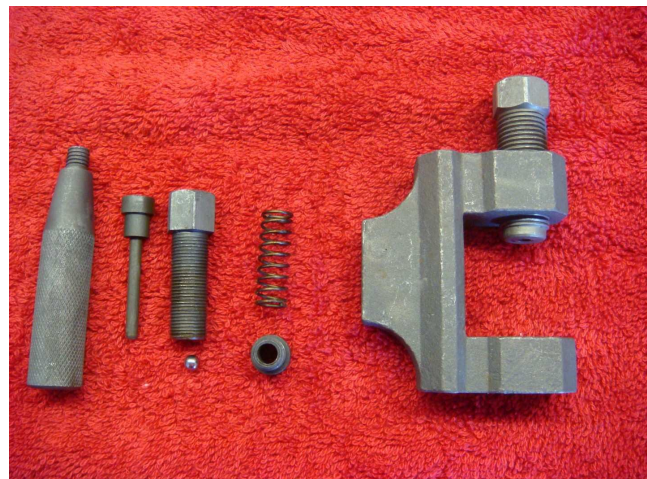
This tool can be found at Harbor Freight Tools for \$9.99 as part number 66488

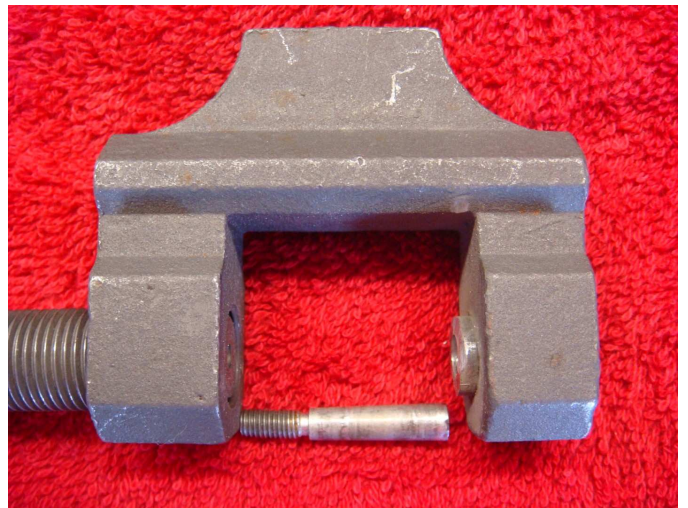
Following Garrett's recommendation, I drilled a $\frac{1}{4}$ " hole in the collet and cut off $\frac{1}{16}$ " from the collet surface. Trimming the collet allows an easier fit, but you can back out the bolt and wiggle the unit over the tapered pin.

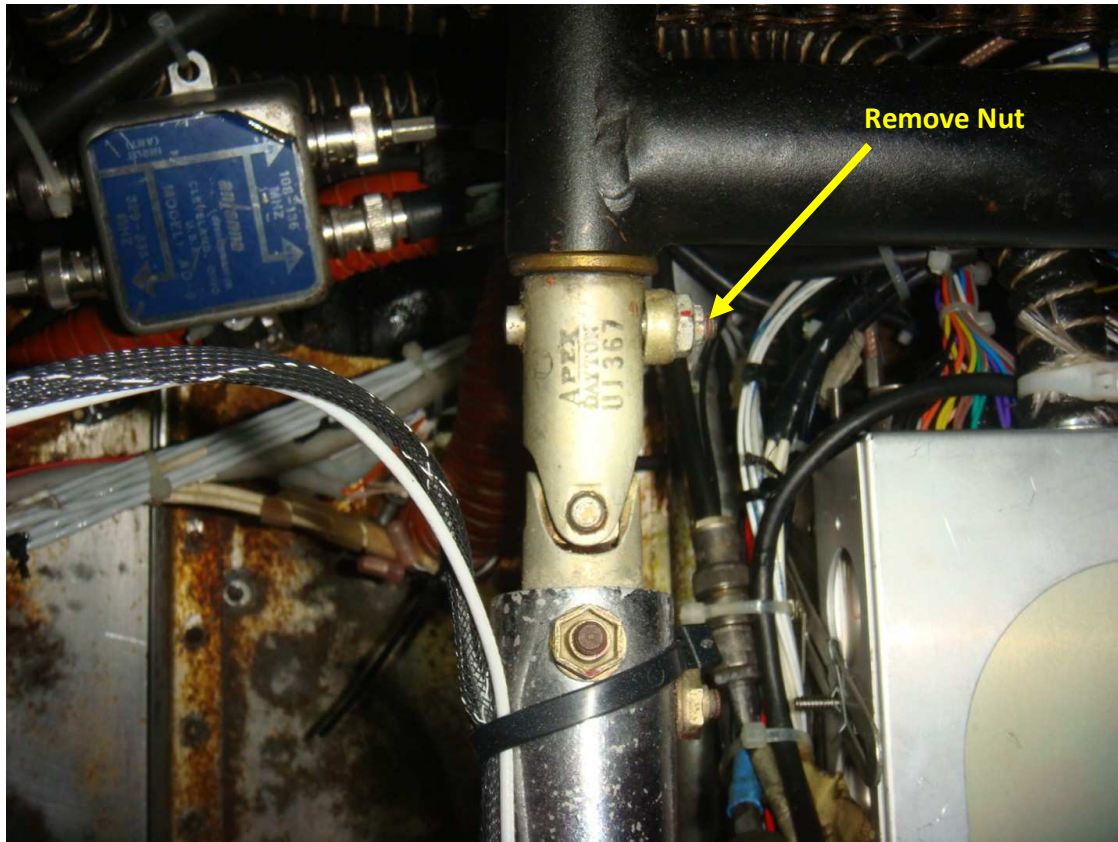
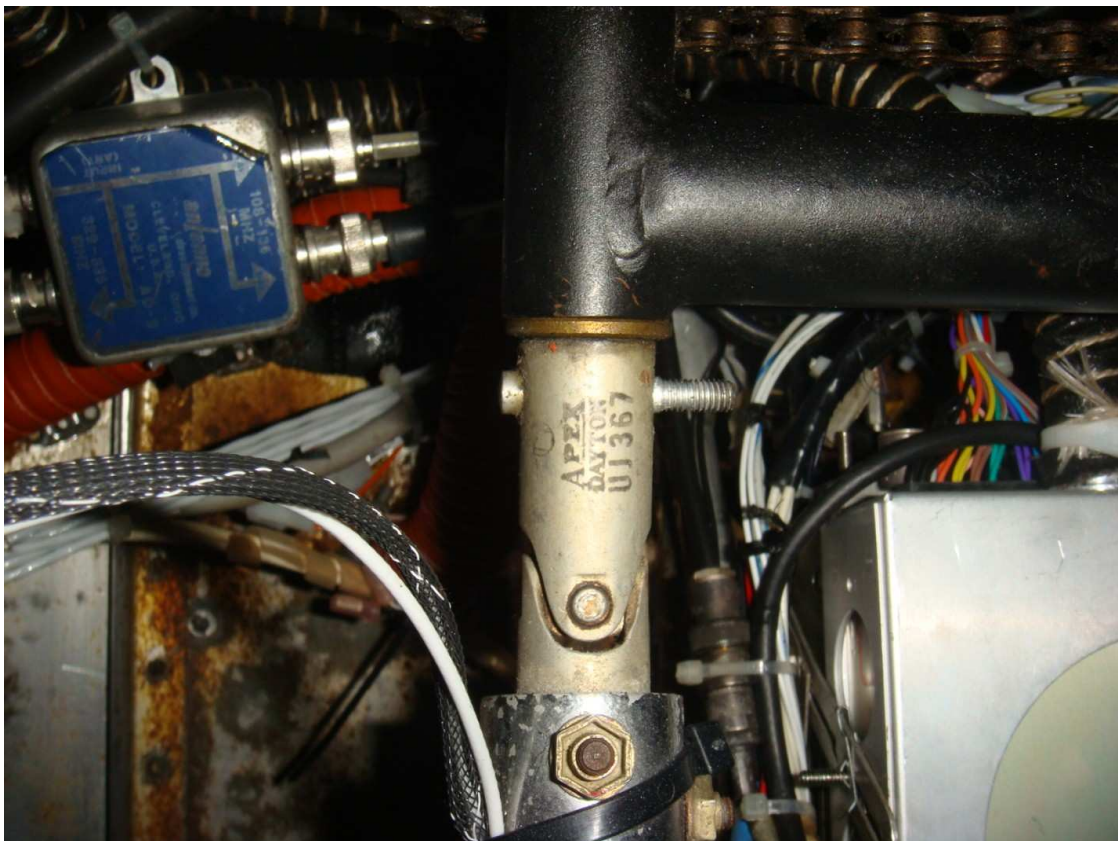
Remove the existing nut on the tapered pin

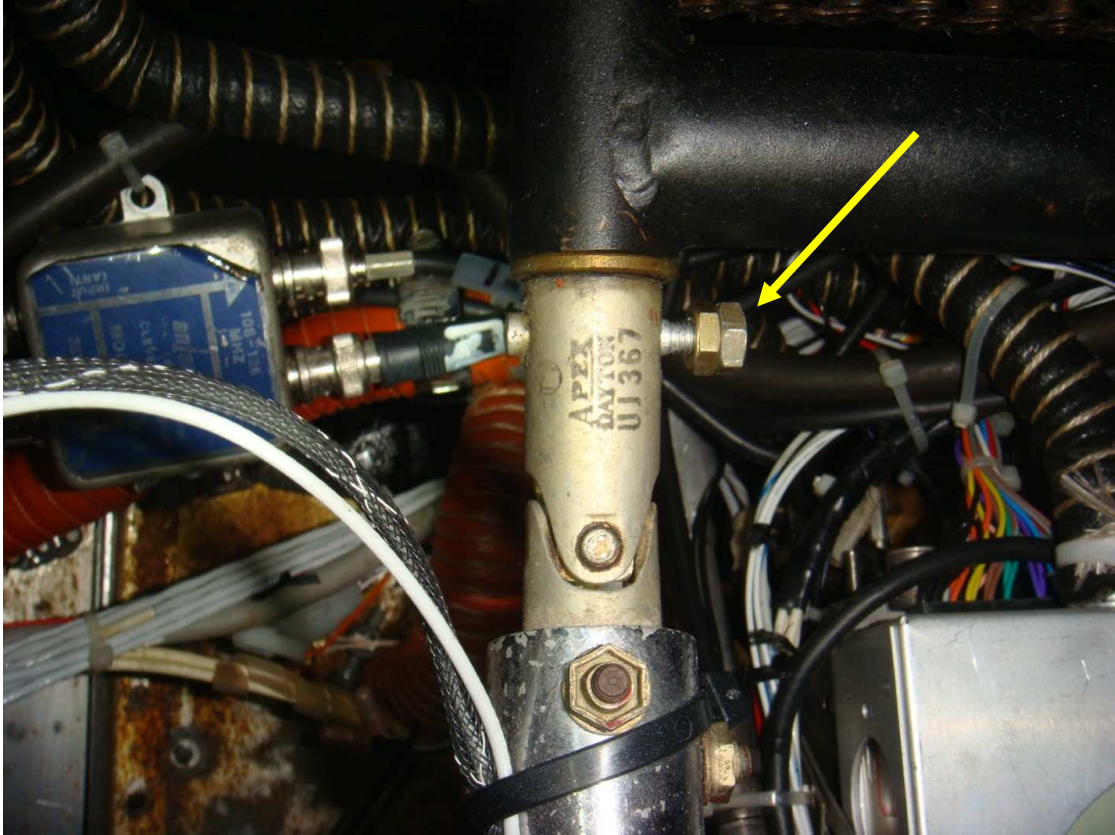
I installed 2 nuts, flush with the tapered pin to provide a pressing surface for the chain breaker and to spread the load on the threads, to avoid bending the pin

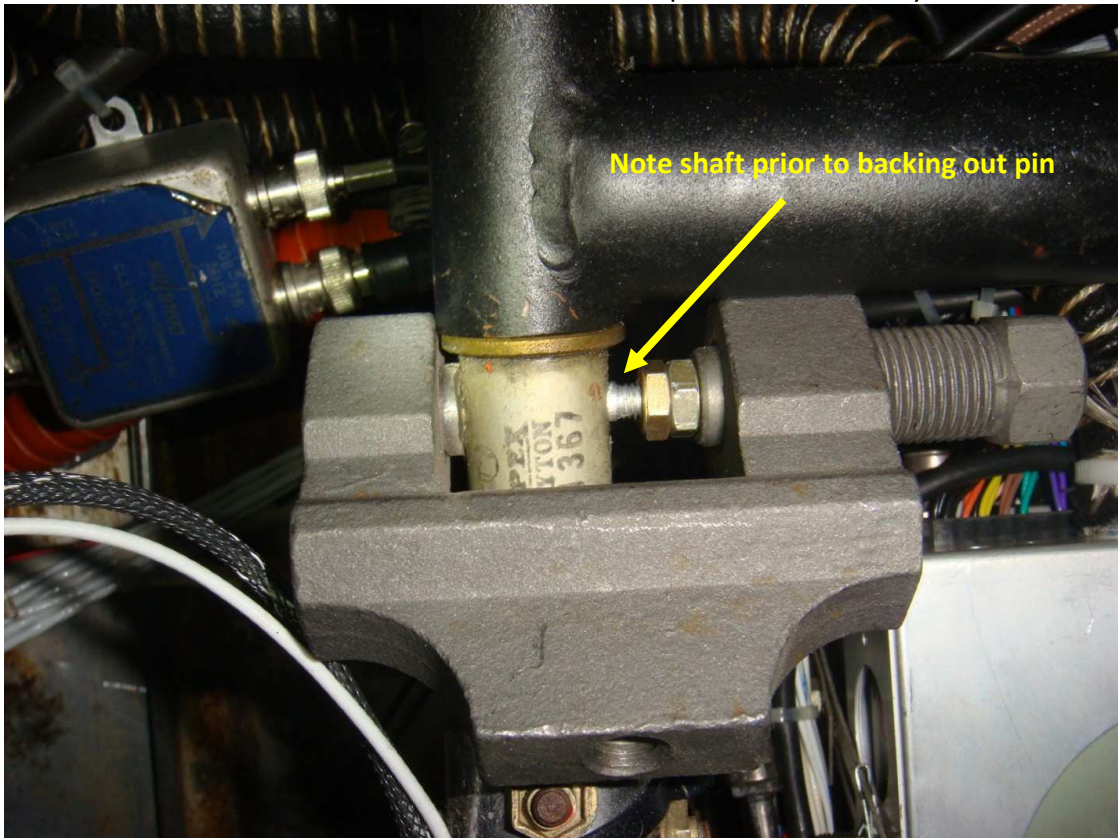
Install the chain breaker – note the clearance from the control sprocket. This is why the collet is needed.

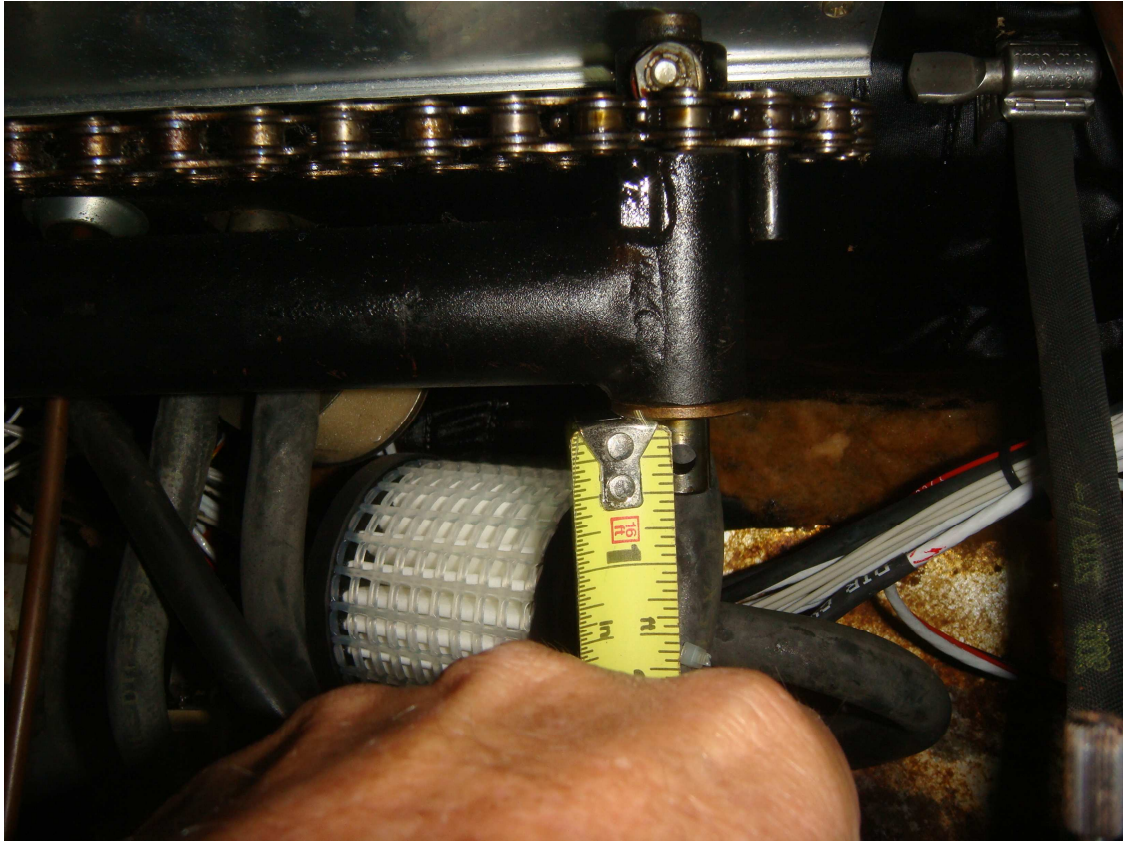
Pilot Shaft

Center of tapered pin hole to end of shaft must be a minimum of 0.19 inches – mine both measured 0.25 inches
